#### **ES-14** **EXTERIOR STRUCTURE:**

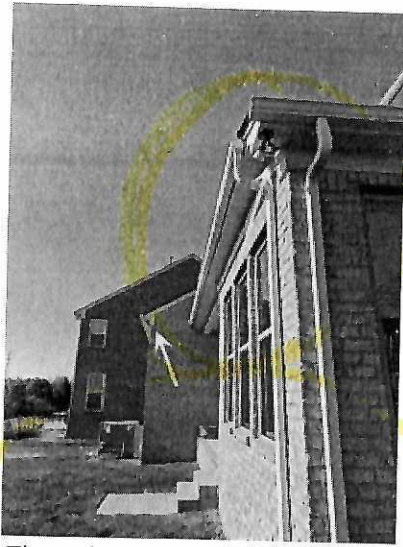
#1

These lights in the back of the home did not respond, possibly on a sensor.

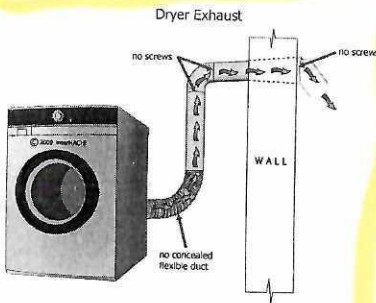
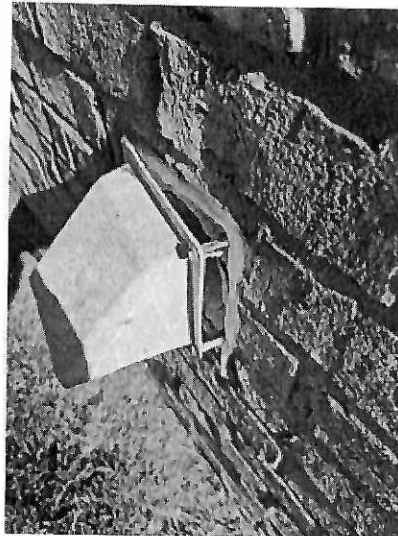
- **Dryer Vent is Improperly Attached** The dryer exhaust damper(cover) is not properly secured to the wall with either fasteners and/or sealant. While it will function it will be much more prone to come loose and fall off.

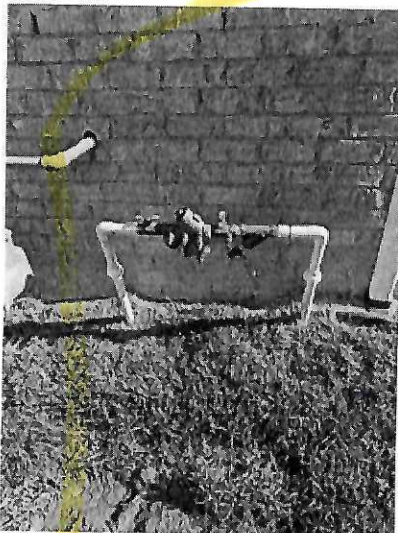
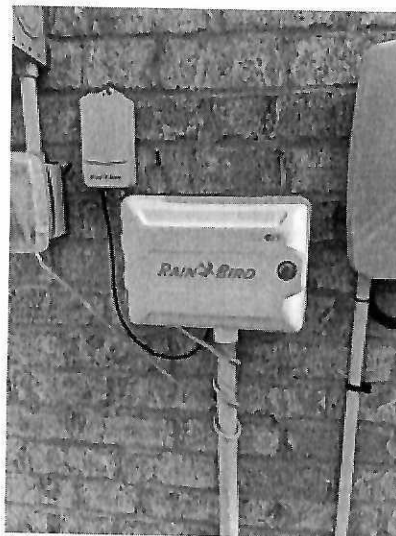
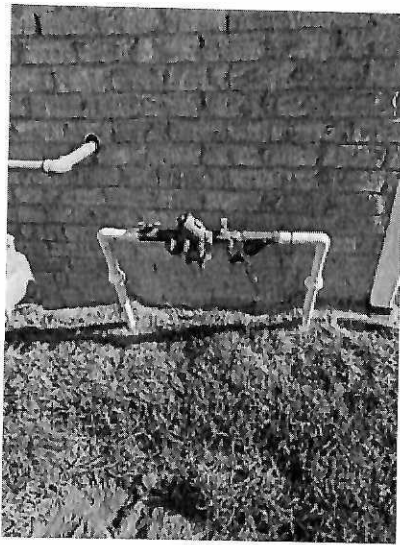
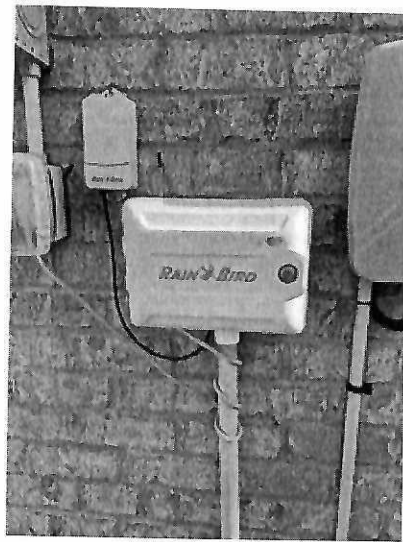
*Irrigation system is present on the property this is not something that is verified by the home inspector. Recommend asking for information on the system from the current owner and making yourself familiar with the maintenance requirements of the system.*

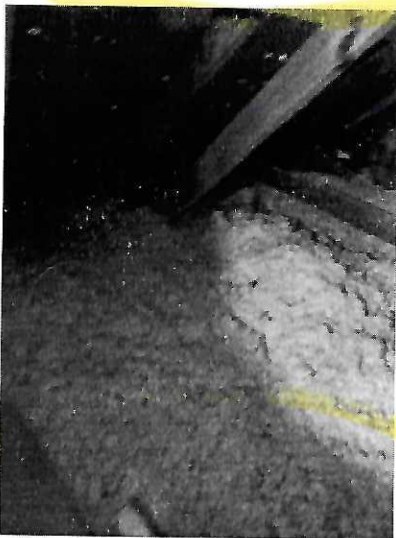
- *Mouse Tunnels in Insulation*--A notable amount of tunnels generally created by mice were noted in the insulation. Consider methods to have them mitigated.

*Several mouse trails and tunnels noted throughout the attic does not appear to be active.*

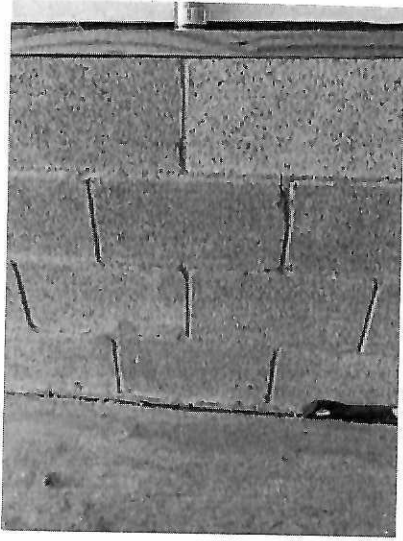
- *Cracks in Wall*--Cracks were noted in the garage cmu walls. Cracking can be due to routine settlement or moderate seasonal expansion and contraction of the home. The seasonal types of cracking can be most problematic as they will tend to re-open after repair.

Typical CMU crack left garage wall

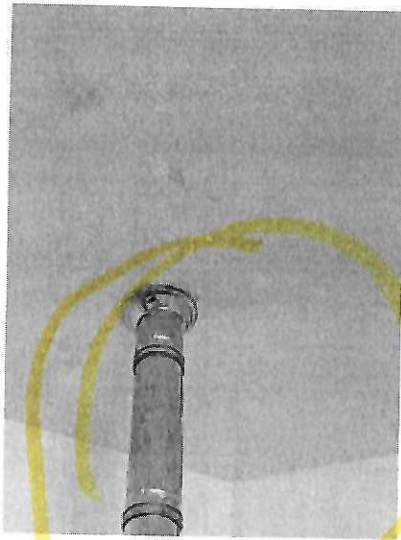
- ~~X~~ *Loose/Missing Tape Seams*--Drywall tape has failed in various areas. It is a safety issue for fire barriers that all joint be sealed with one coat of drywall mud and taped. This is generally a rather simple repair.

Minor tape seam crack garage ceiling

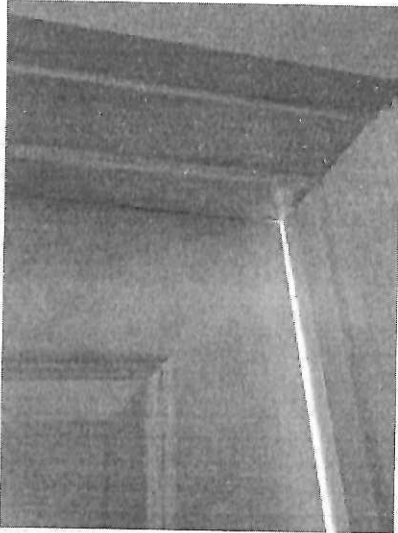
**\*Latch Not Engaging**--The door latches were not engaging properly or, are easily opened. This can be caused by worn-out parts, a misaligned strike plate, or a warped door.

Master bedroom rubs top right corner

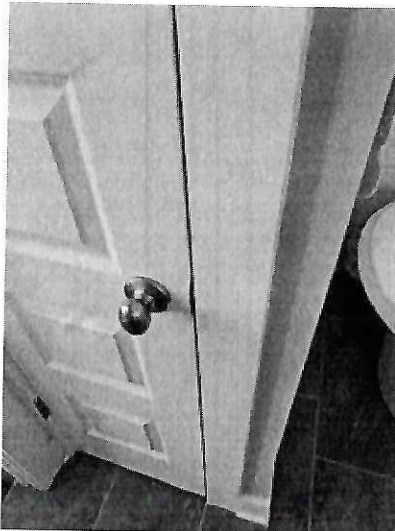
Master bath closet does not latch

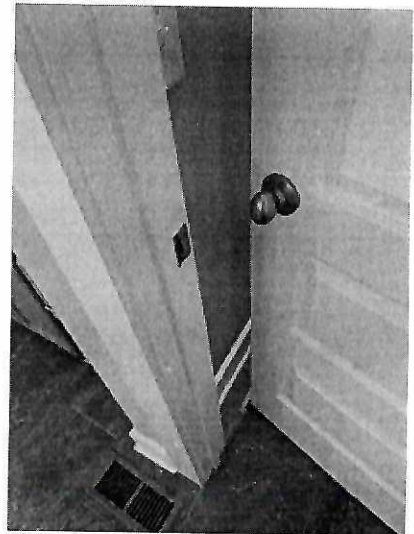
Master bath toilet does not latch

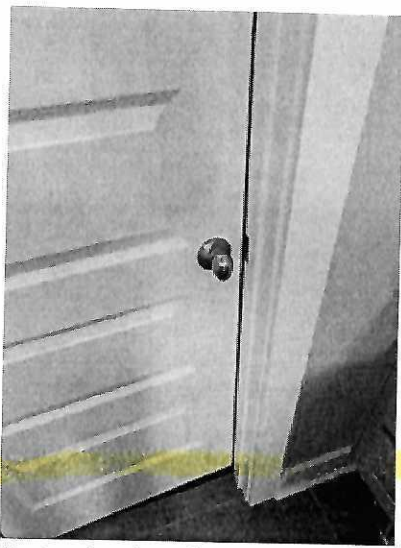
Master bath to large closet does not latch

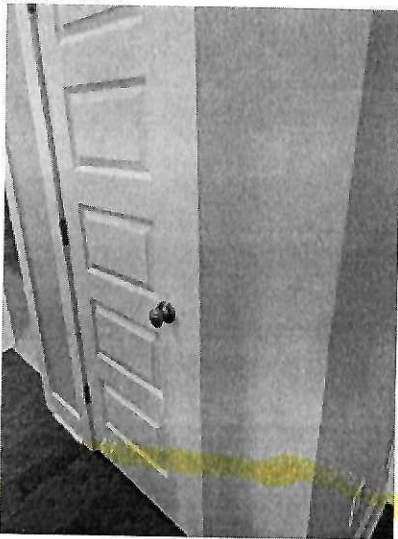
- ~~X~~ **Loose Knobs**--Door knobs or levers are loose or difficult to turn. This can be caused by worn-out screws, improperly installed hardware, or a damaged door latch mechanism.

Closet door knob loose across from bathroom 2

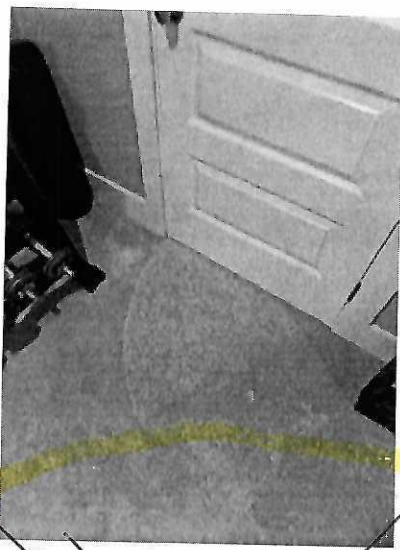
Bottom of the door has a small chip from contact.

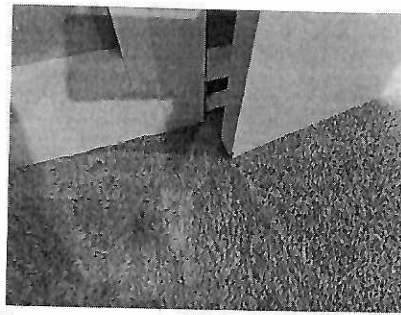
Door to the upstairs HVAC cannot be opened all the way due to contact with the carpet. If the bottom of the door is trimmed ensure that there is not a large air gap below the door as this is an unconditioned space.

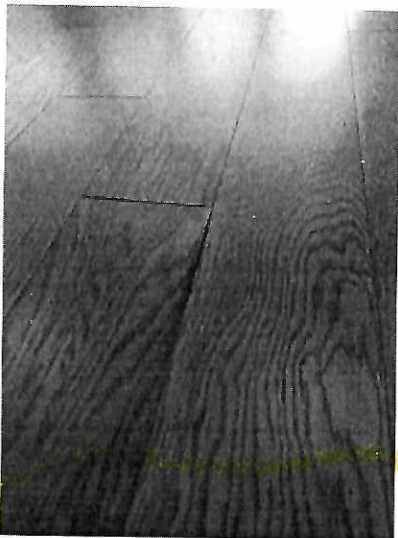
- ✱ **Areas of Minor Damage**--Flooring showed areas with minor damage such as dents or scratches. While in some cases this can be repaired, it is largely a cosmetic issue.

This plank is slightly bowed up this is where the front hallway opens into the living room

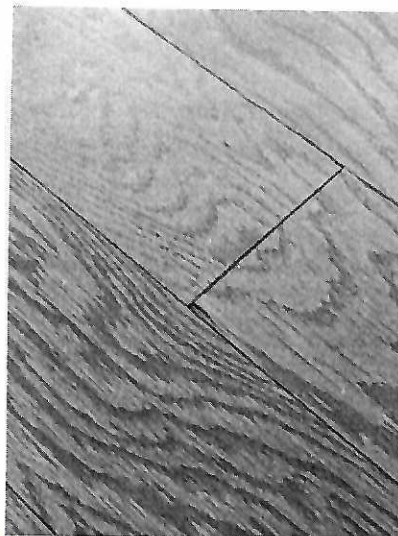
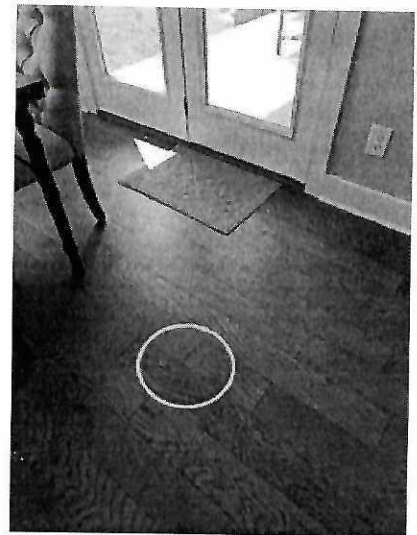
This is in the dining room near the back door see next photo

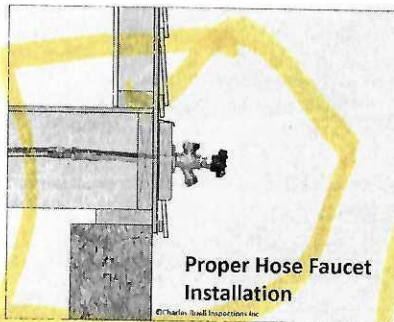
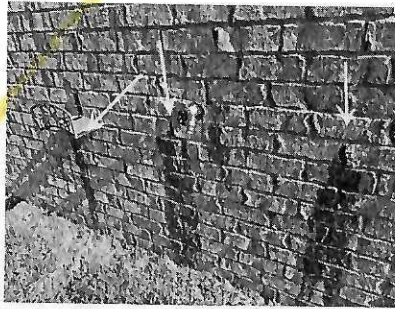
*Leaking (When Operated)*--The hose bib(faucet) be repaired to avoid wasting water and to prevent moisture from accumulating next to the foundation. Even leaks which appear inconsequential can add significant quantities of moisture to the soil over time.

*Hose bib on the right side has an internal leak when turned on it starts leaking from the weep holes.*

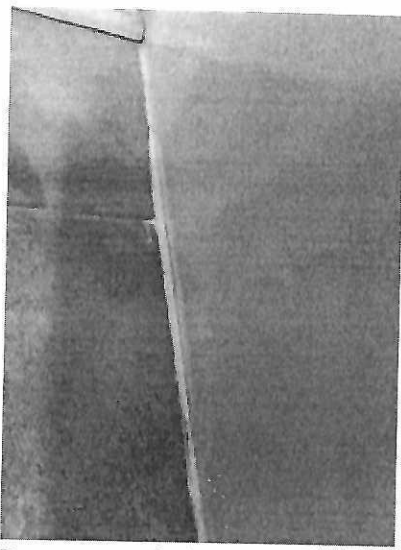
*Recommended resealing along front of tub*

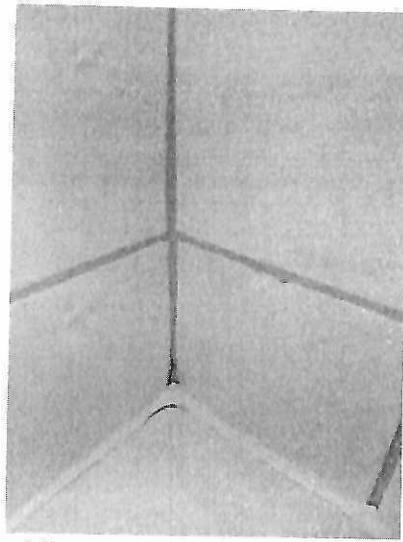
*Minor cracks in grout in the corners, recommend using sealant*

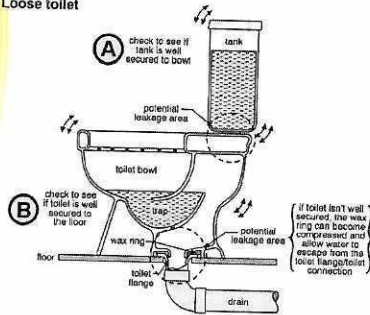
✖ *Loose Toilet Bolts* - The loose bathroom toilet needs to be reset and the wax ring and flange should be replaced to prevent hidden plumbing leaks if needed. Repairs can be simple or more complex depending on the problem with the wax ring and flange, how the bolts are set and if any water damage exists below the floor.

Loose Toilet

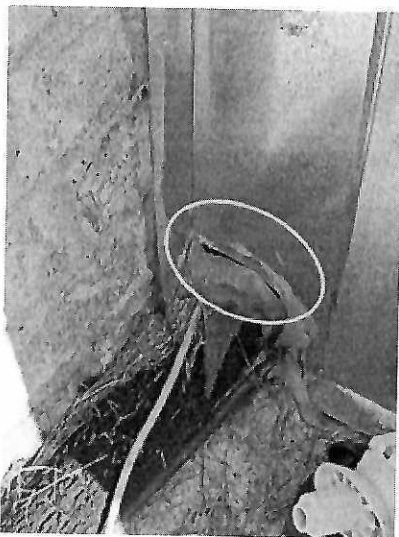
- ✖ **Gaps in Flashing Shroud**--The exterior flashing shroud connecting the unit to the home had gaps at the connection point. 1/2 inch is enough to become an entry point for pests seeking warmth during the winter. Have these properly sealed to help reduce entry points.

Recommend resealing this area  
on the flashing

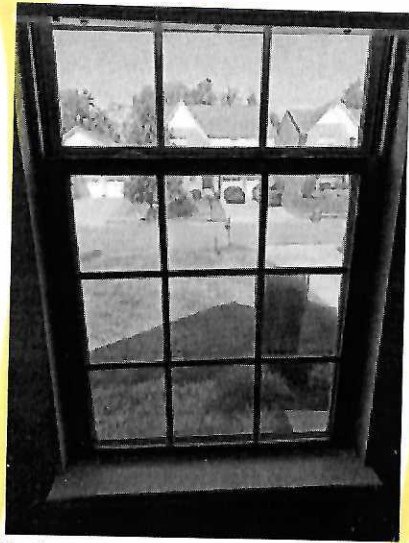
*Bedroom 3 window upper pane showing signs of delamination, this is a cosmetic concern and does not affect the performance of the window.*

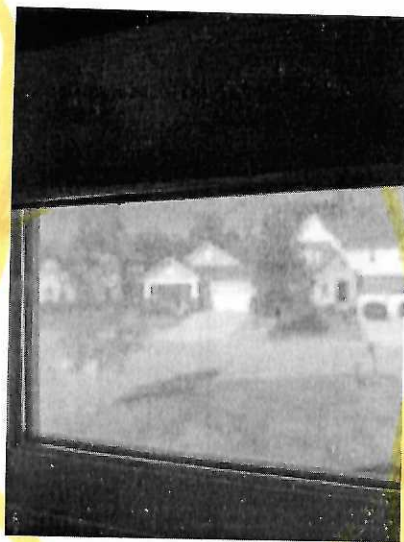
*Back center living room window appears to be compromised*

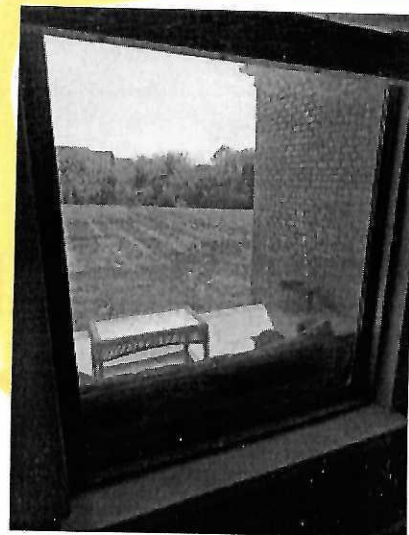
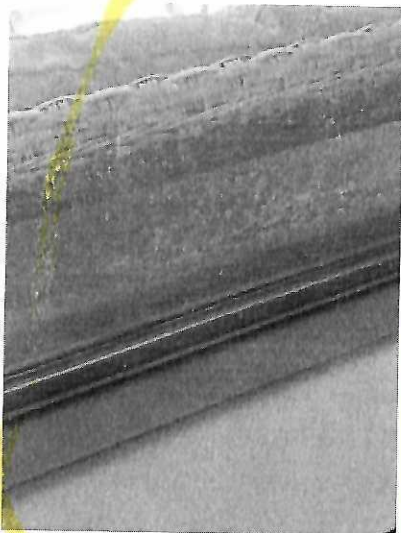
*Water stains between the glass*

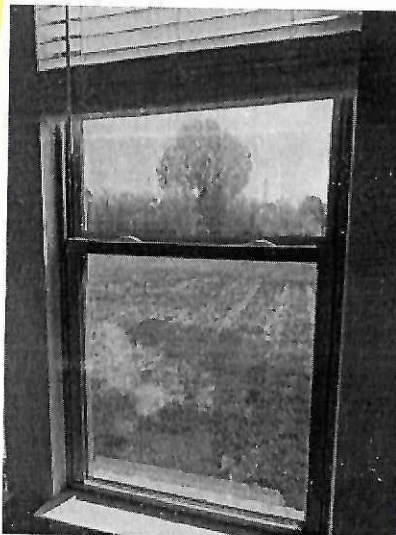
*The right rear dining room window upper pane, has delaminating film.*

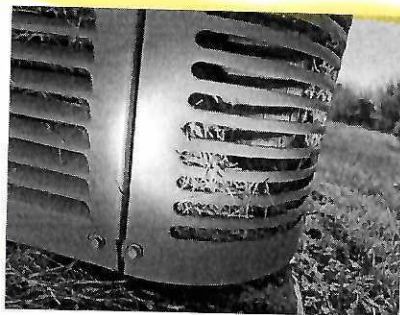
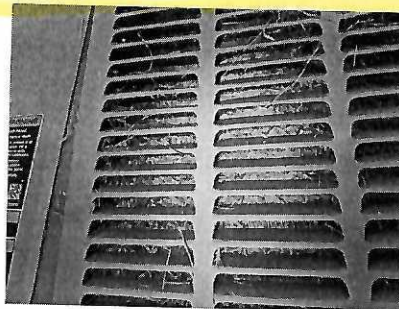
Upstairs heat pump unit has grass blocking some of the cooling fins. This is hard on the unit and reduces performance

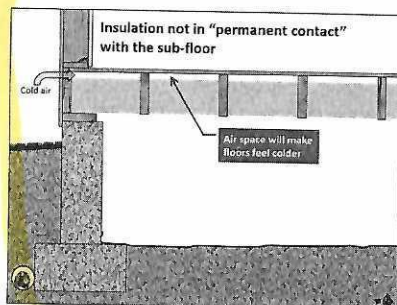
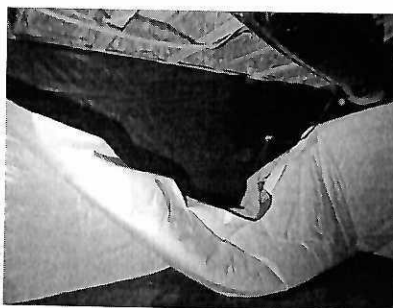
- ✖ **Tune-Up [Falling/Sagging]**--The sub-floor insulation in the crawl space requires tune-up repair. Secure all loose and sagging insulation. Be sure the entire sub-floor is insulated. When making repairs it is best to seal any noticeable air leaks between the crawl space and the living space. Check all penetrations through the floor.

Insulation on the left front corner of the home has fallen down on the wall.

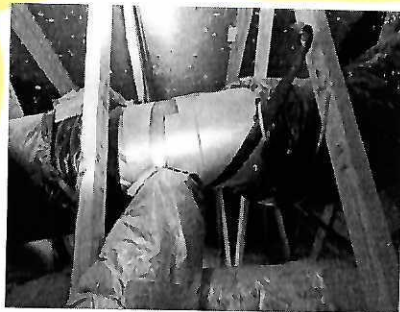
*This section of ductwork does not have any insulation. This is above bedroom 1 several feet from the attic steps.*

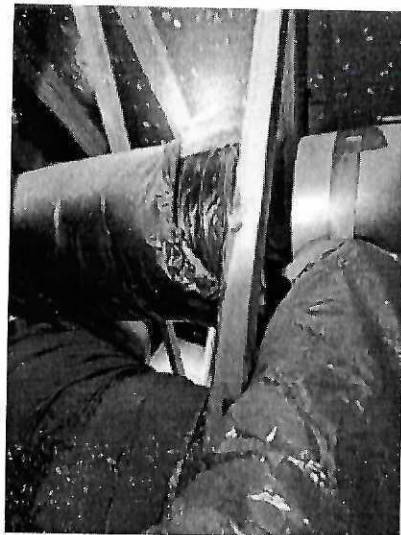
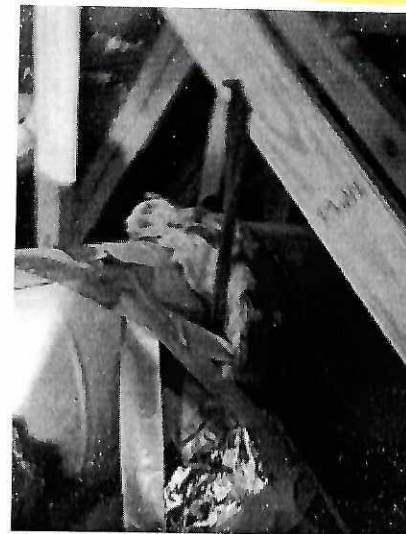
*On the back side someone has used duct tape, a foil backed tape is recommended for any repairs.*

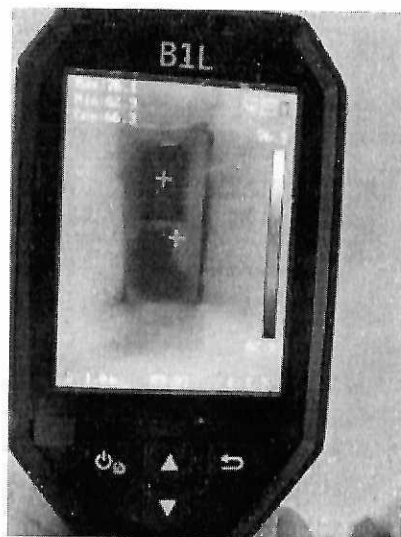
*Service is recommended--* The HVAC unit **does not appear to be adequately functioning**. The temperature difference from the intake to the output was less than recommended. Service or repairs of the unit are likely warranted. For older units this may require additional work or replacement.

*Upstairs 62.9°  
Upstairs room temperature is 70° this equals a 7° differential  
minimum is 14° recommend servicing.*
