#### **ES-14** **EXTERIOR STRUCTURE:**

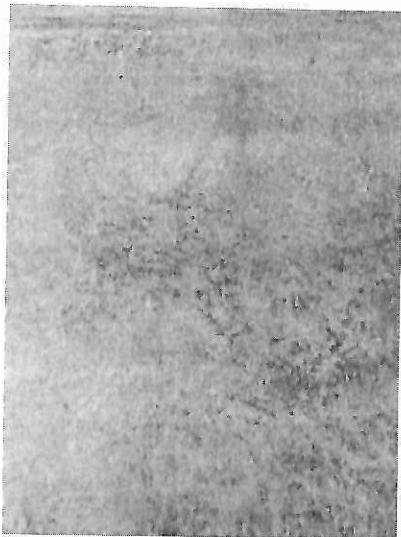
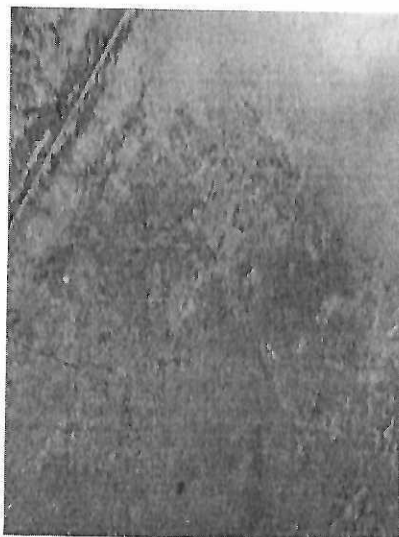
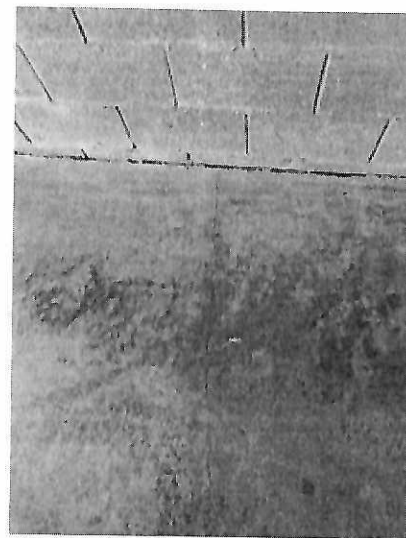
- ~~X~~ *Loose/Missing Tape Seams*--Drywall tape has failed in various areas. It is a safety issue for fire barriers that all joint be sealed with one coat of drywall mud and taped. This is generally a rather simple repair.

- *Cracks in Wall*--Cracks were noted in the garage cmu walls. Cracking can be due to routine settlement or moderate seasonal expansion and contraction of the home. The seasonal types of cracking can be most problematic as they will tend to re-open after repair.

Typical CMU crack left garage wall

Minor tape seam crack garage ceiling

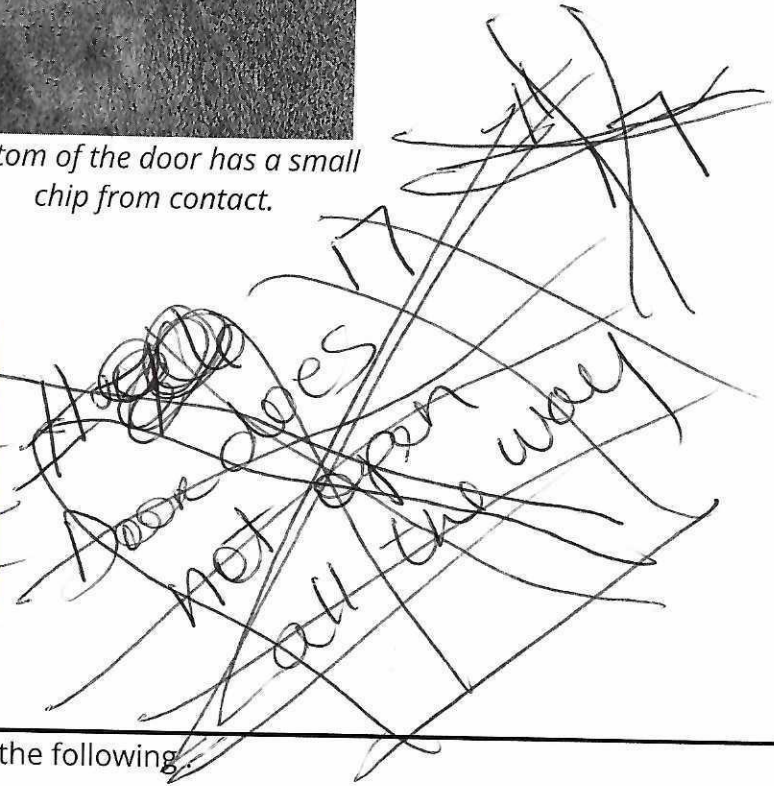
Bottom of the door has a small chip from contact.

Door to the upstairs HVAC cannot be opened all the way due to contact with the carpet. If the bottom of the door is trimmed ensure that there is not a large air gap below the door as this is an unconditioned space.

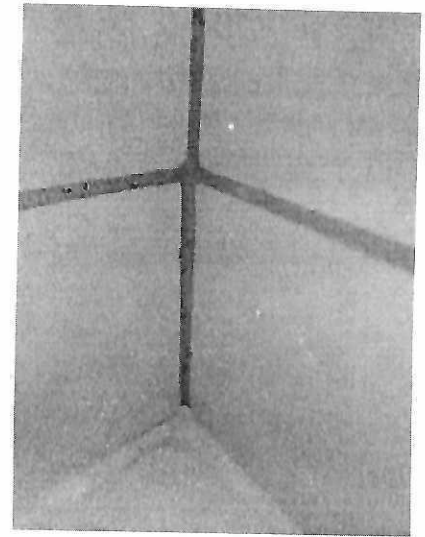
*Minor cracks in grout in the corners, recommend using sealant*

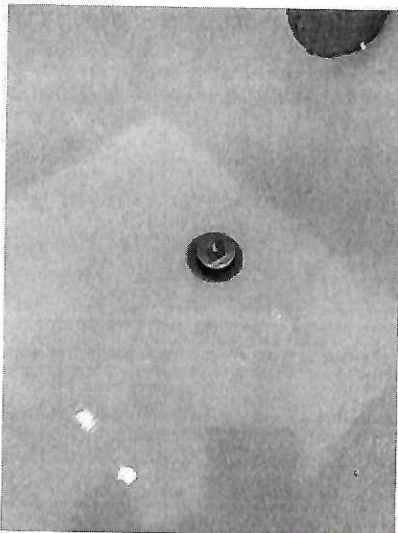
#10

- ✖ *Slow drain* - The bathroom bathtub has a drain that is slow and appears to be obstructed.

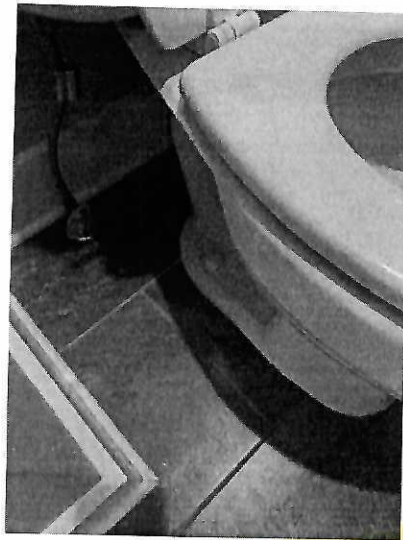
#11

✖ *Loose Toilet Bolts* - The loose bathroom toilet needs to be reset and the wax ring and flange should be replaced to prevent hidden plumbing leaks if needed. Repairs can be simple or more complex depending on the problem with the wax ring and flange, how the bolts are set and if any water damage exists below the floor.

Loose Toilet

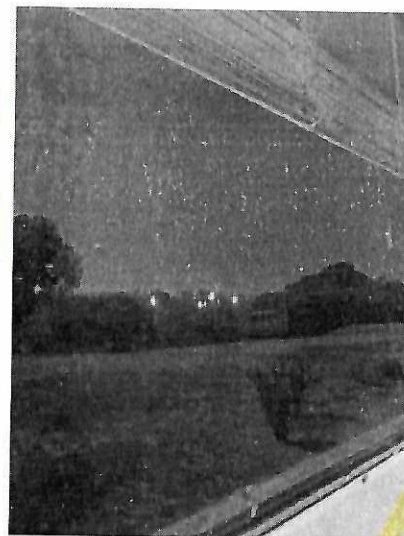
#12

*The right rear dining room window upper pane, has delaminating film.*
